DATSUN

Technical Bulletins

1979

JANUARY — DECEMBER 1979

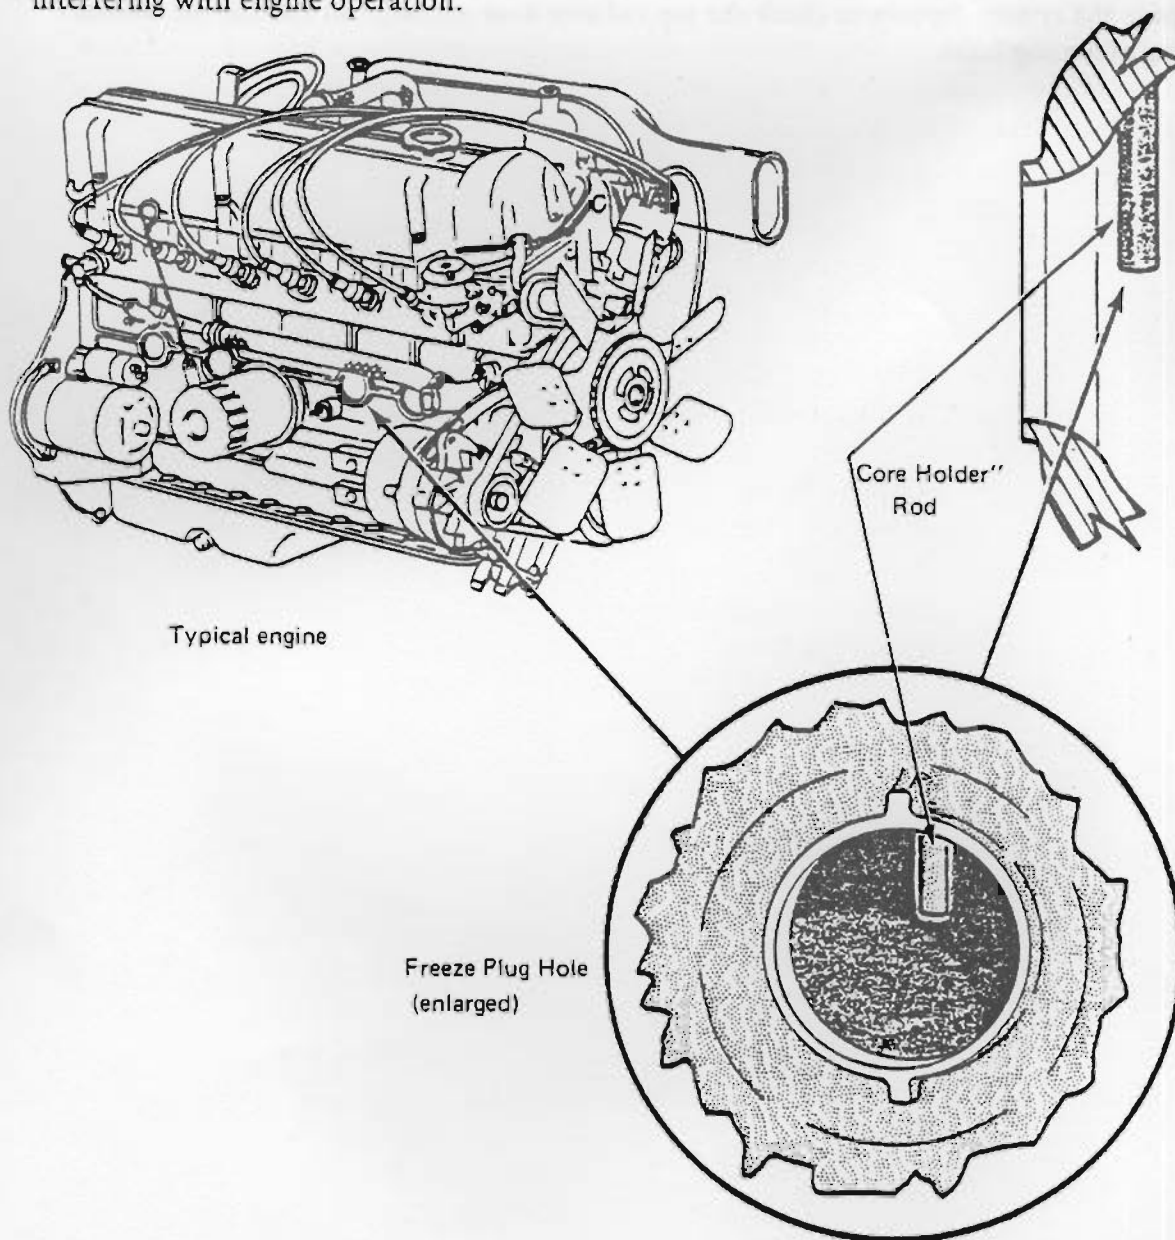
Service Information. When installing engine block heater P/N 99990-00032 or 99990-00033 in Datsun vehicles, a 3/16" diameter "core holder" rod located in the water jacket, may interfere with installing the block heater into the freeze plug hole. If the "core holder" rod interferes with the installation, the rod may be removed or bent as necessary without interfering with engine operation.

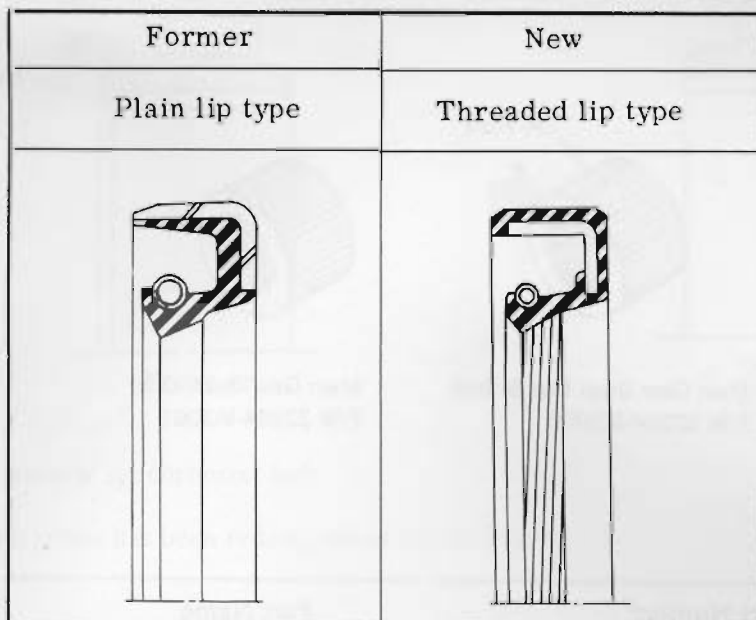
Production Change. The oil seal sealing the torque converter to the front extension of the oil pump on 3N71B transmissions, installed in B210 and 210 models, has been changed from a plain lip type to a threaded lip type seal.

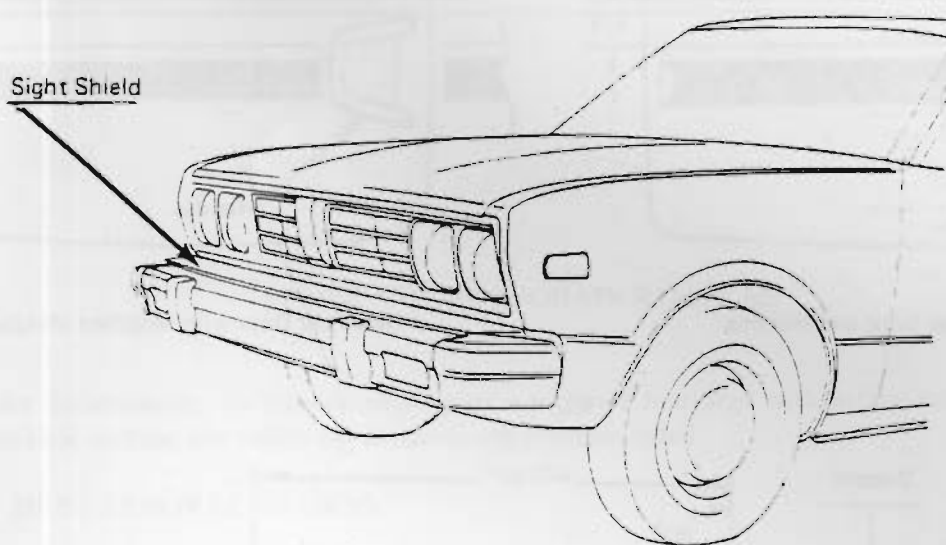
Service Information. Vibration and buzzing noises similar to tire balance, drive line, or wheel bearing symptoms, occurring in early production 510 models, that cannot be corrected by conventional means, may be caused by the front bumper sight shield vibrating. Tape the gap between the bumper and the sight shield, to prevent air from passing underneath the sight shield causing it to vibrate. If taping the sight shield corrects the vibration, install a later model shield.

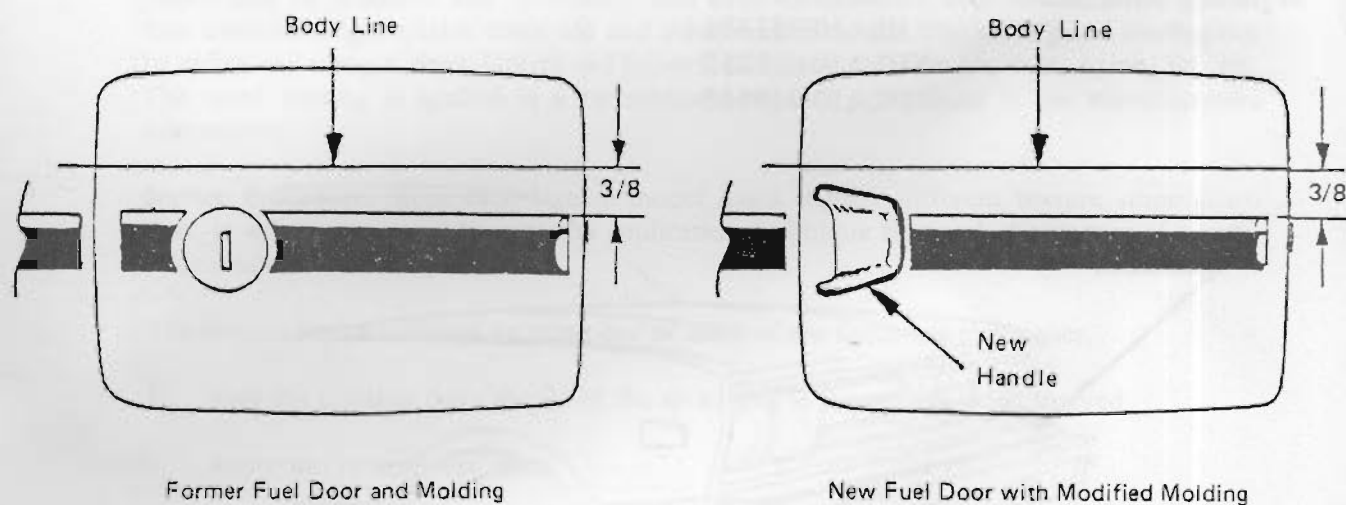
Fig. 1

Service Information. Due to a minor product change to 210 models, body side molding kits will have to be modified before installation, as illustrated below.

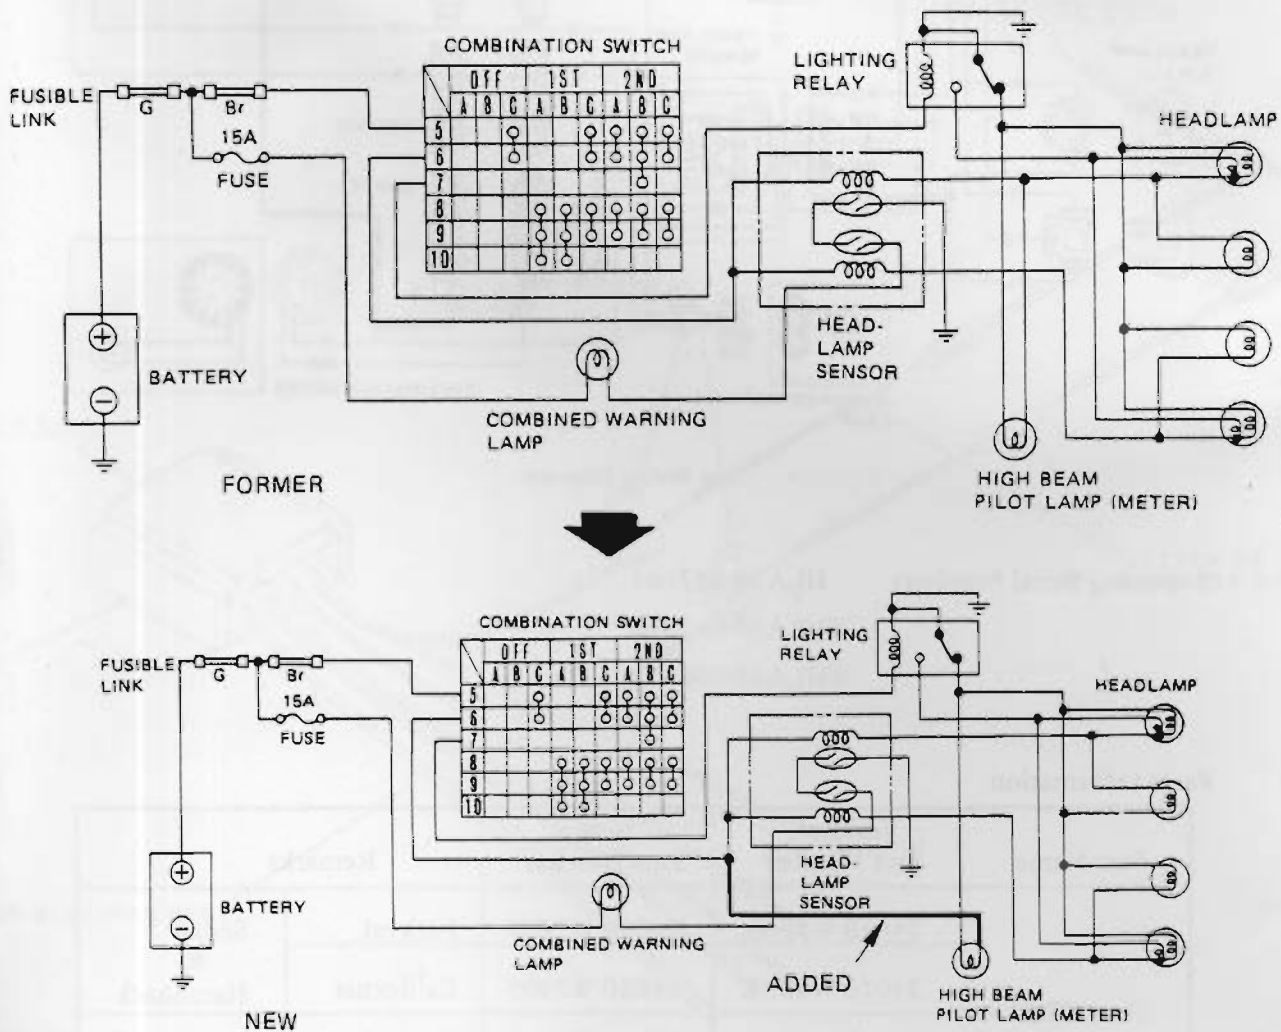
Former and New Operational Schematics

Production Change. To improve the operation of the high beam pilot lamp, the headlamp circuit has been modified as shown below. The pilot lamp indicates the headlamp system is set to operate on high beam. Abnormalities in the system are indicated by the warning lamp. Along with this change, the main harness has also been modified. We suggest you note this change in your 510 Service Manual.

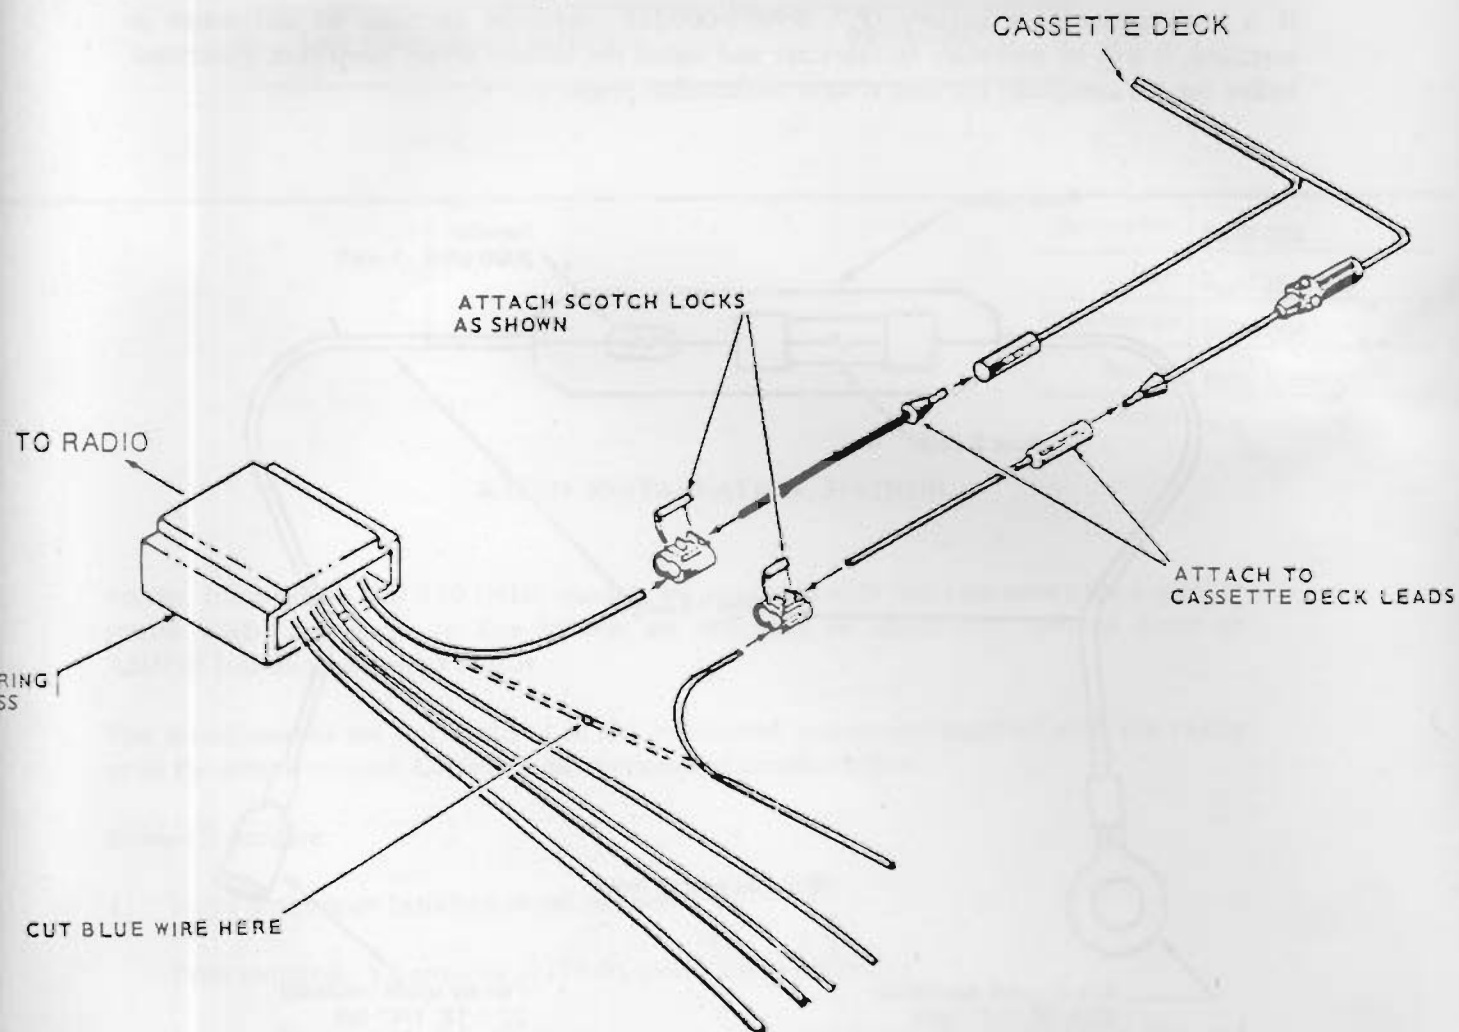
Service Information. When installing cassette deck B9315-M9000 in N10 (310) vehicles, it will be necessary to modify the radio's wiring harness as illustrated below. The necessary "Scotch Locks" and lead wires are supplied with the cassette deck.

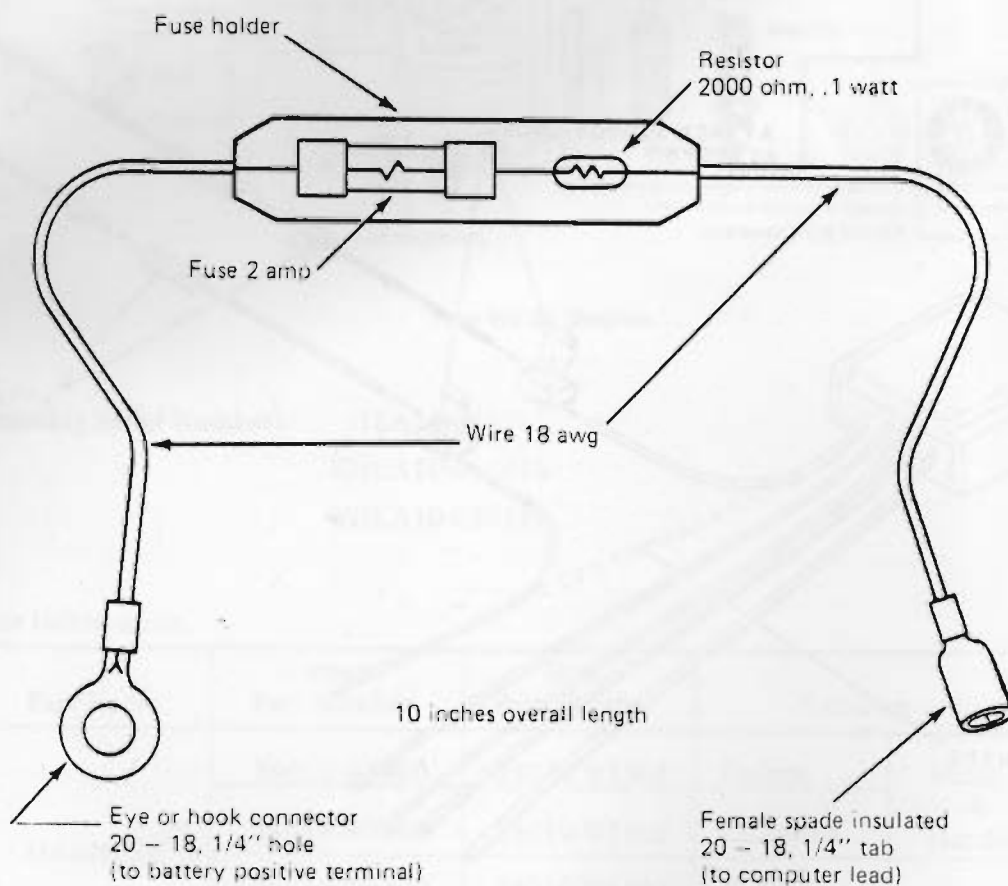
280-ZX Battery Sensor Substitute

If a low maintenance battery (P/N 99996-00026), without openings to add water is installed, it will be necessary to fabricate and install the battery sensor substitute illustrated below for the computer warning system to function properly.

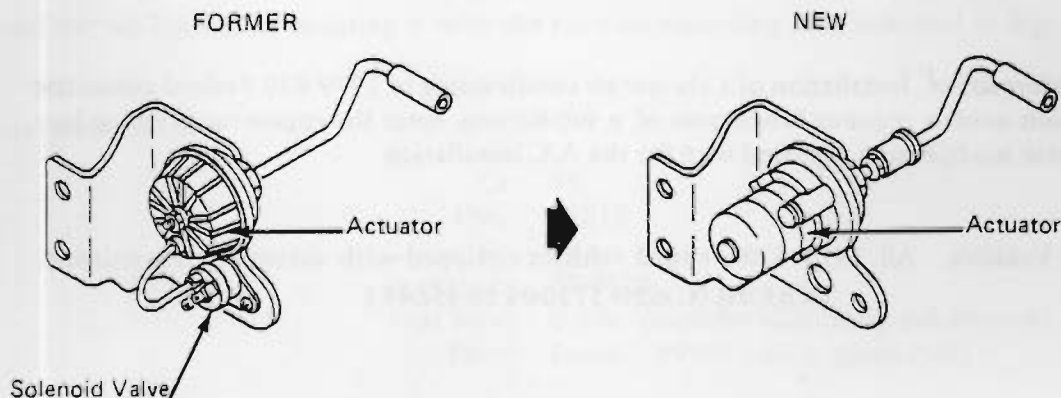
Production Change. To ensure quiet operation, the FICD actuator installed in Factory air conditioned N10 (310) models has been changed.

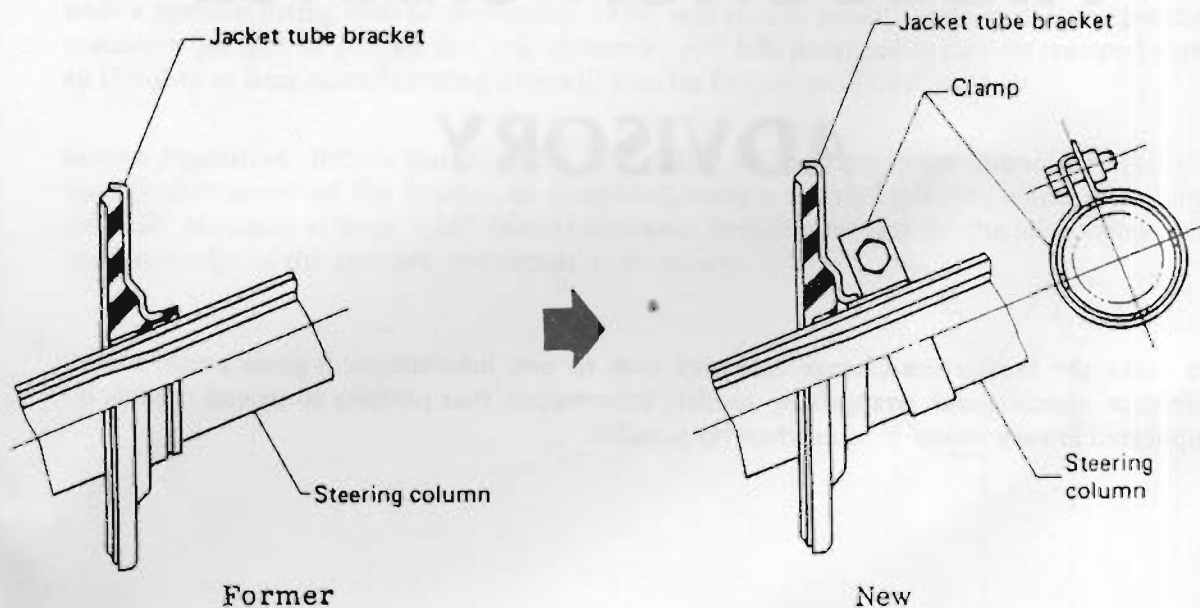
To reduce vibration in the instrument panel and steering wheel, the method of mounting the steering column and jacket tube bracket has been changed.
