DATSUN

Technical Bulletins

1979

JANUARY — DECEMBER 1979

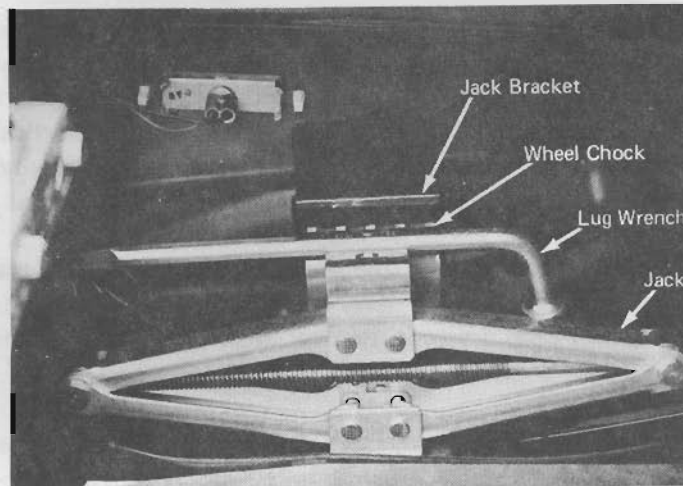
Fig. 1

1. Place the wheel chocks in the jack bracket.
2. Place the jack in the jack bracket.
3. Place the lug wrench between the jack and the top of the wheel chocks, Fig. 1.

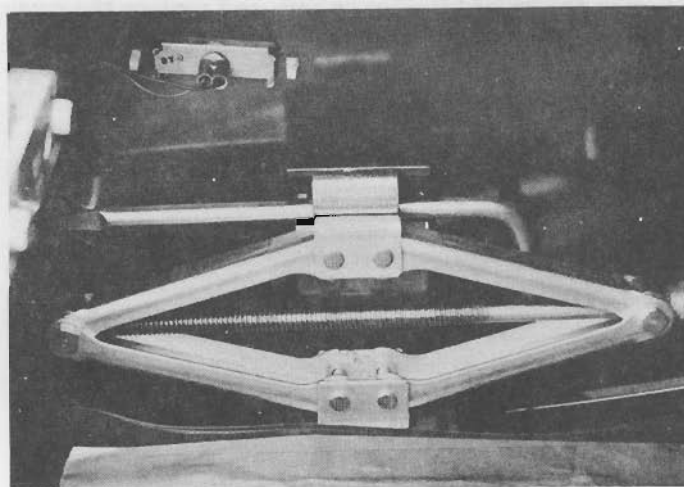
Fig. 2

4. Tighten the jack to wedge the lug wrench securely against the wheel chocks. Ensure the lip of the jack bracket fits securely into the slot of the jack.

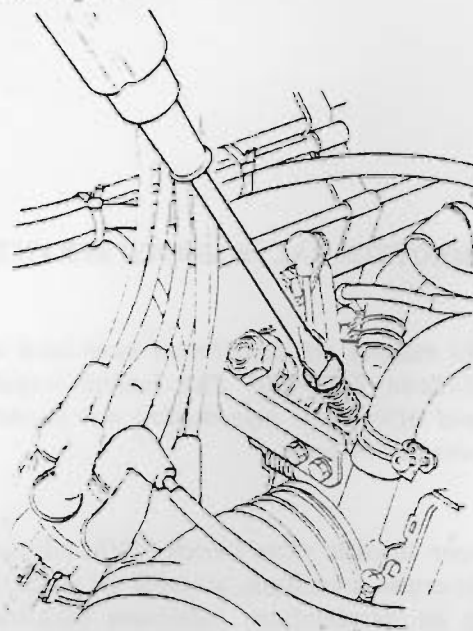
Fig. 1 Adjusting engine idle speed

6. With engine at normal operating temperature, use the idle speed screw to set idle speed to specifications (Fig. 1).

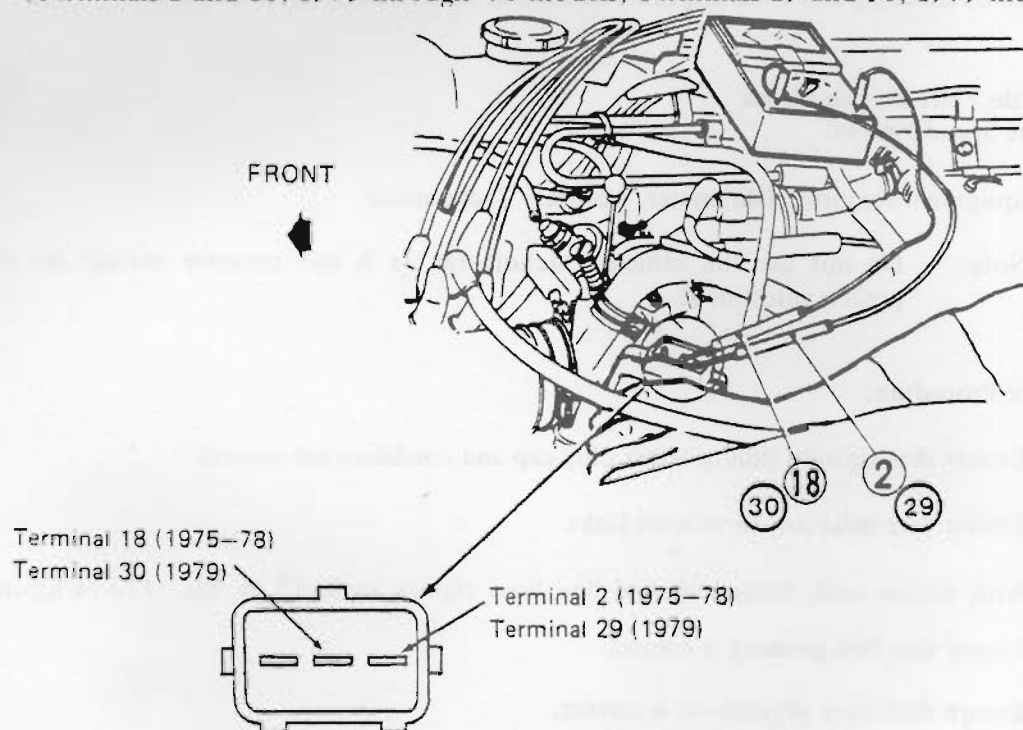
Fig. 2 Connecting ohmmeter to throttle switch.

7. Disconnect the throttle switch harness connector from the throttle switch body.
8. Connect an ohmmeter to the right and middle terminals of the throttle switch body. (Terminals 2 and 18, 1975 through '78 models, Terminals 29 and 30, 1979 models)

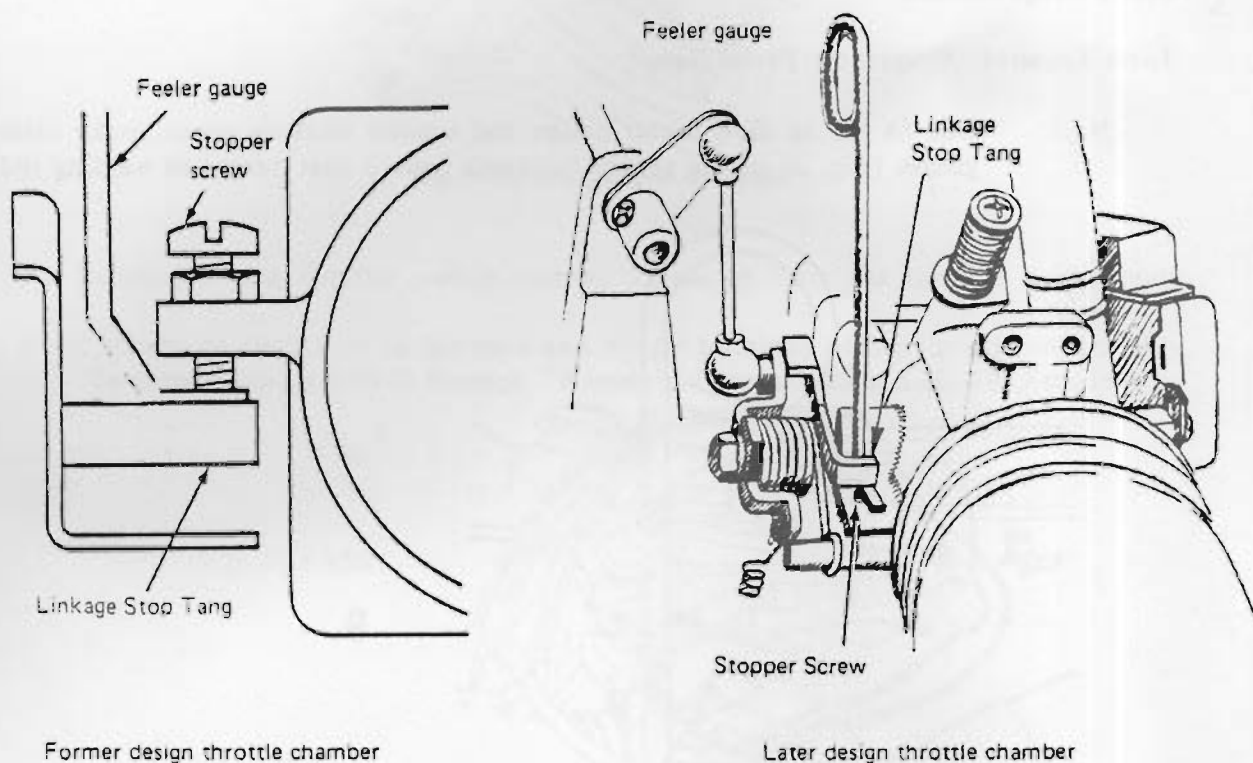
Fig. 4 Place feeler gauge between stop tang and stopper screw.

1. Follow the procedure outlined in Steps 1 to 7 of the TVS check, to insure the running condition of the vehicle and the proper connection of the ohmmeter.
2. Manually open the throttle linkage and place a feeler gauge of the proper size between the linkage stop tang and the red stopper screw (Fig. 4).

IMPORTANT: Do not, under any circumstances, disturb the setting of the linkage stopper screw.

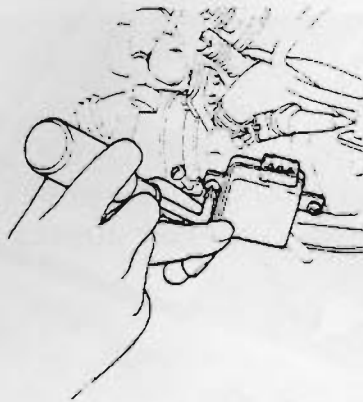
Fig. 5 Loosening the throttle switch screws

3. Loosen the throttle switch body mounting screws (Fig. 5) and rotate the throttle switch body clockwise until the ohmmeter shows a closed circuit.

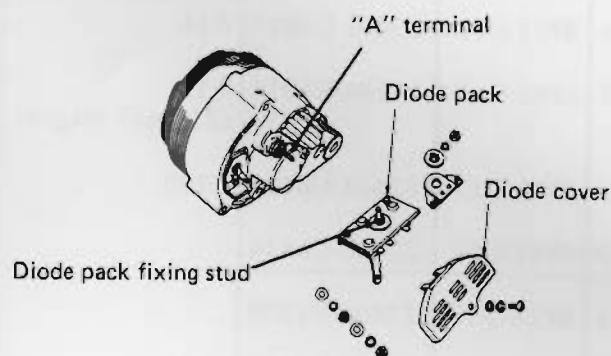
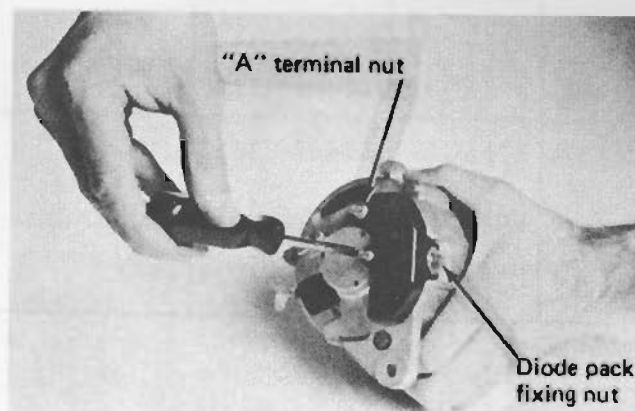
Service Information. When replacing diode packs in the type of Hitachi alternator illustrated below, it is important that the diode pack fixing nut and "A" terminal nuts are tightened in the correct sequence to prevent the diode pack from separating.

1. Install the new diode pack in the alternator case and resolder the stator leads.
2. Install the plastic diode cover and tighten the diode pack fixing nut first.
3. Tighten the "A" terminal nut last.

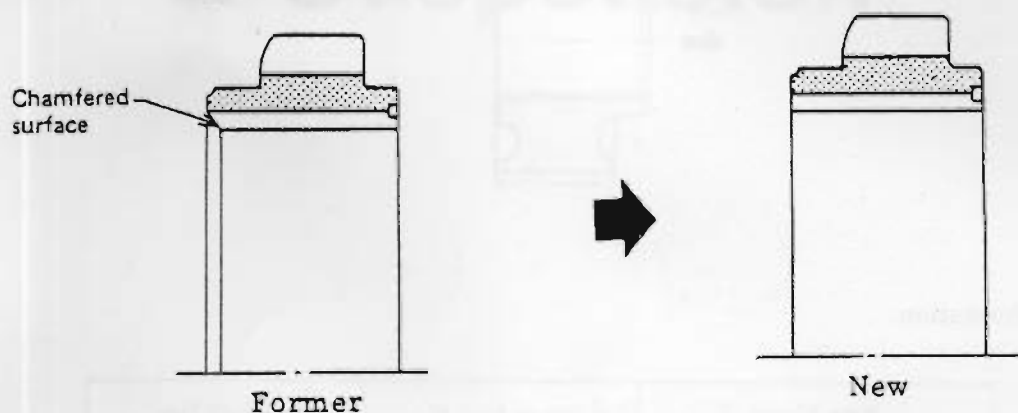
1. Reverse main gear.

Production Change. To improve operation and standardize parts, the reverse main gear and overdrive — reverse hub have been changed.

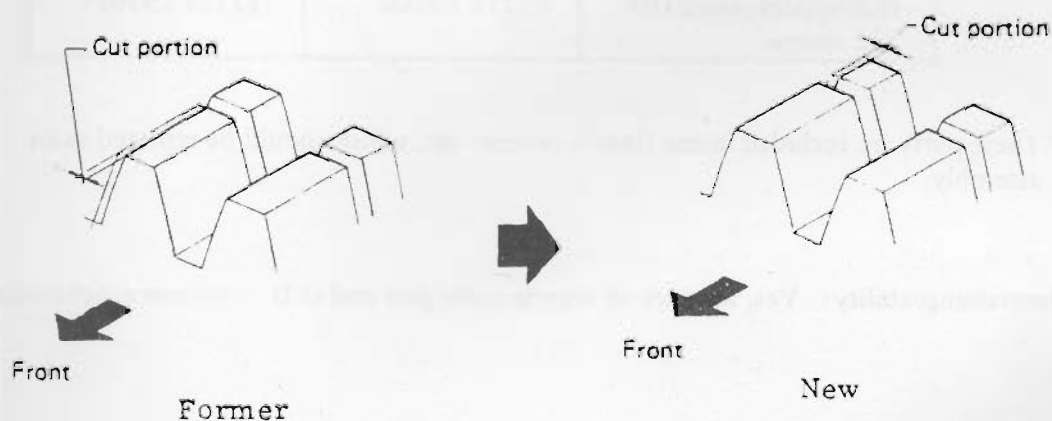
2. OD — Reverse synchronizer hub

The hub spline has been redesigned as shown below.

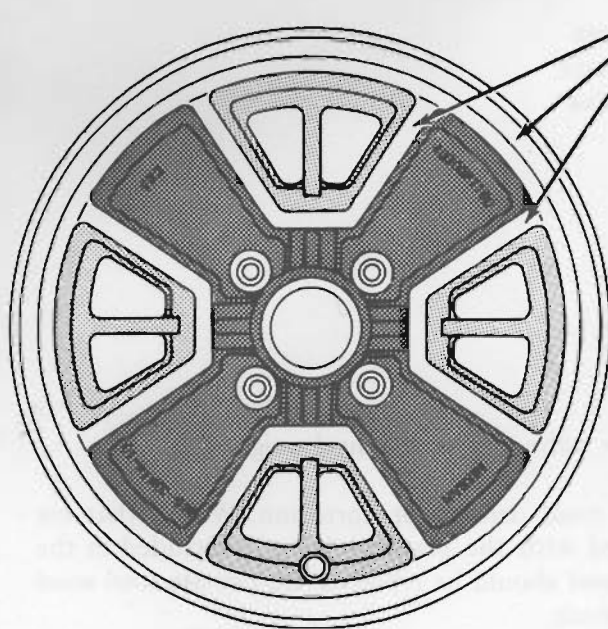
Service Information. Factory aluminum road wheels on which the protective clear coating is cracked or peeling can be refinished with the new mag wheel recoat kit (P/N 99990-00549). The kit contains all necessary materials to strip and recoat one complete set of factory aluminum wheels.

8. Mask off all the machined surfaces of the wheels as illustrated below. Place a plastic plug (included in the recoat kit) in each lug nut hole.
9. Following the paint manufacturer's recommendation, apply three medium coats of the appropriate color paint to the areas of the wheels illustrated below. Allow each coat to flash dry prior to application of the next coat.

Mask off all machined surfaces.

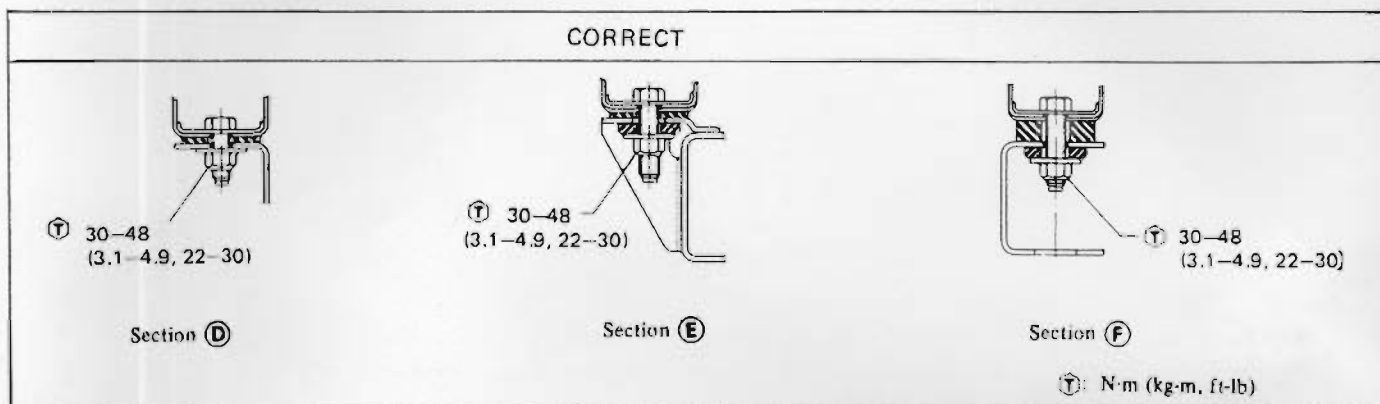
In the Body and Frame Section of the 1980 720 Service Manual, page BF-26, the figures at the bottom, labeled Sections D, E and F, contain incorrect torque specifications. The correct torque specification is 22-30 ft.lbs. Please correct your copy by hand.

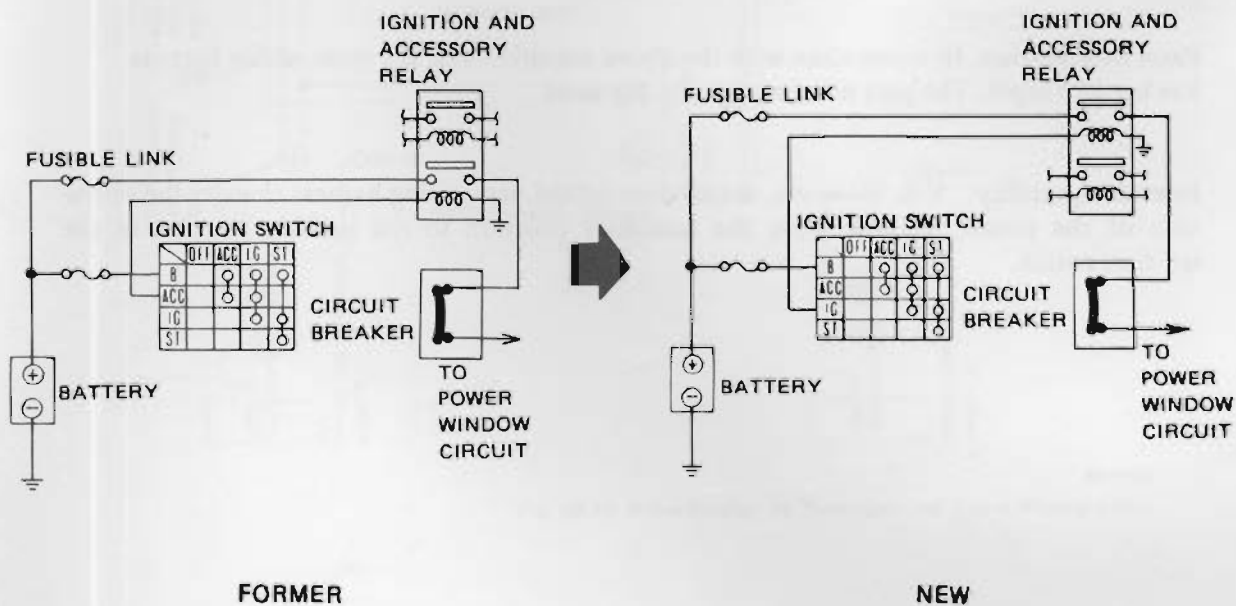
Production Change. To increase the performance stability of the power window and the Automatic Speed Control Device (A.S.C.D.), modifications have been made to the power circuits of the 280-ZX as illustrated below. The enclosed booklet should be kept in your 280-ZX Service Manual to update the Body Electrical (BE) Section.

1. The power window is now activated by current from the ignition circuit rather than the accessory circuit.

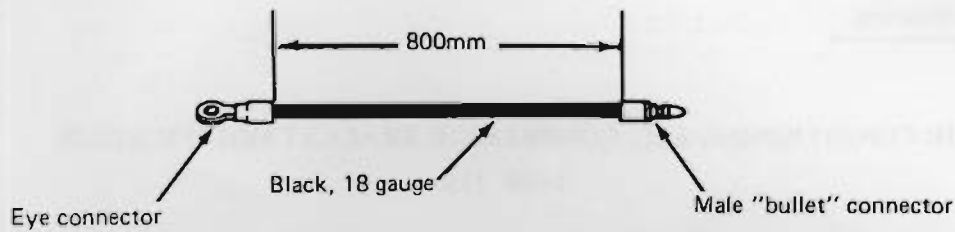
Fig. 1

Service Information. Installation of Calsonic air conditioning in 1979 620 Federal automatic transmission models requires fabrication of a sub-harness, since the engine room wiring harness in these models lacks a ground wire for the A/C installation.

Service Procedure. Fabricate the sub-harness from an 800mm (32") length of 18 gauge wire by attaching a male "bullet" connector to one end and a 1/4" eye terminal to the other end, as illustrated in Fig. 1.

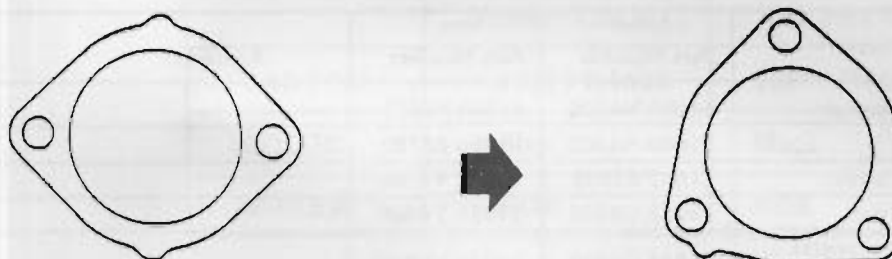
Fig. 1

To improve sealing, the water outlet of the L24 engine has been changed from a 2-point to a 3-point mounting, as illustrated in Fig. 1. Along with this change, the inside diameter of the water pipes has been increased from 8mm to 10mm (Fig. 2).

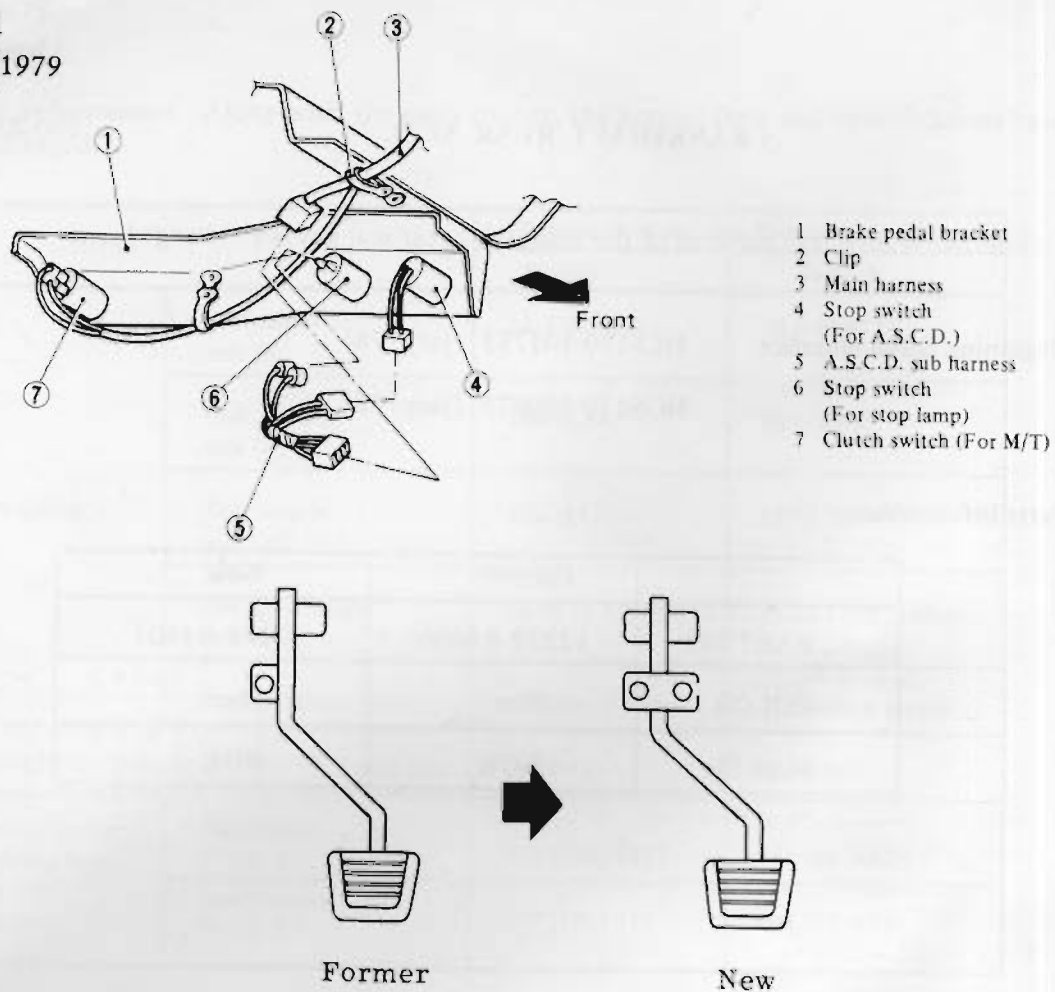
To standardize parts, the combination ASCD set release switch (stop switch) and stop lamp switch has been changed. The combination stop switch has been replaced with a stop lamp switch and an ASCD set release switch. To accommodate the additional switch, the brake pedal and bracket have been modified and an ASCD sub harness has been added.

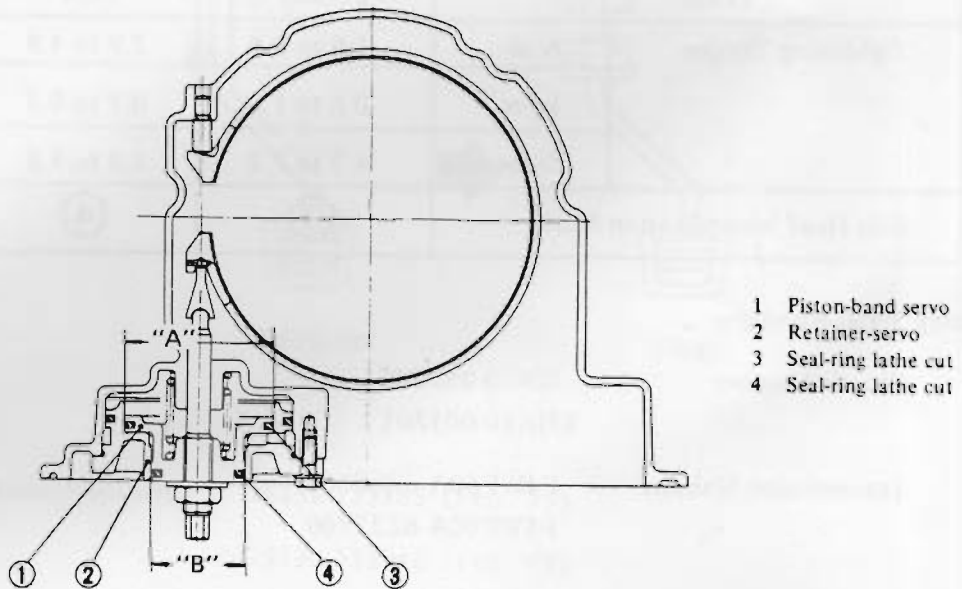
Band Servo Piston

To improve shifting performance, the diameter of the band servo piston has been decreased and the former rigid brake band has been replaced by a new flexible band. Also the orifice check valves, in the control valve assembly, have been redesigned.

Former	New
Big dia. "A"	64 (2.52)	60 (2.36)
Small dia. "B"	40 (1.57)

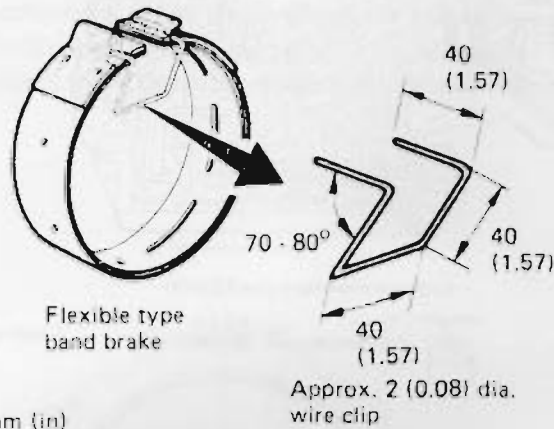
Service Information. Expanding the new flexible band can cause the lining to crack or peel. When removing the new flexible band secure it with a clip as illustrated below.

When installing the brake band, coat the lining with transmission fluid, attach the band strut, and remove the clip.

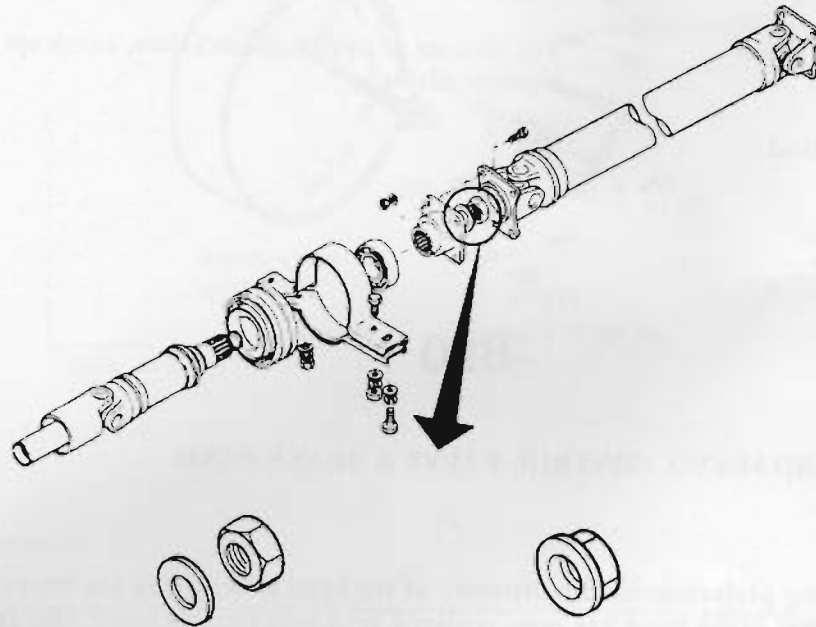
Type A
(Nut and washer type)

The propeller shaft calking nut and plain washer have been combined as illustrated. Along with this change the tightening torque of the calking nut has been revised.

Ⓙ: 20.0 to 24.0 kg-m
(145 to 174 ft-lb)

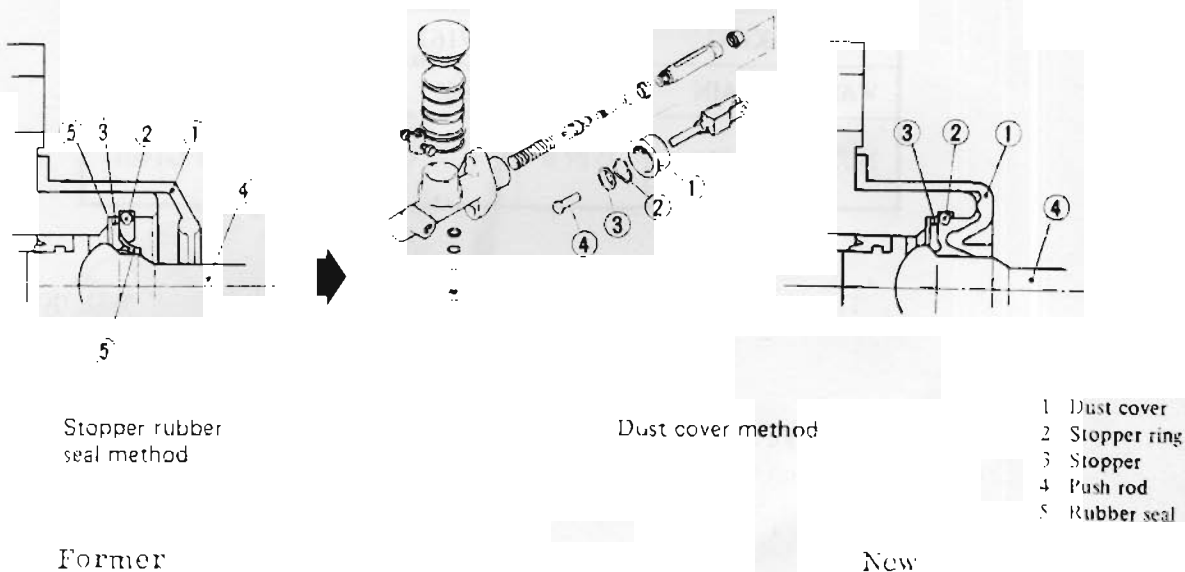
To simplify servicing, the method of sealing the clutch master cylinder has been changed. It is now sealed by the dust cover rather than the stopper's rubber seals. In the new cylinder design, the dust cover has been redesigned and the stopper's rubber seals have been eliminated.

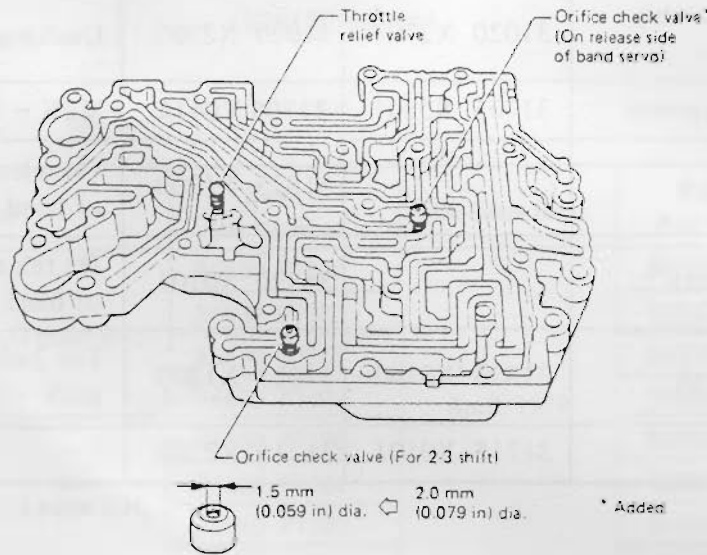
Orifice check valve

To improve shifting performance, an orifice check valve (on the release side of the band servo) has been added and the bore diameter of the orifice check valve (for 2-3 shift) has been decreased. Also, the bore diameters of the separate plate (on the release side of the band servo and the apply side) have been decreased.
